# STICKLE POND DAM

## PHASE I INSPECTION REPORT NATIONAL DAM SAFETY PROGRAM

NJ 00285

JULY 1978

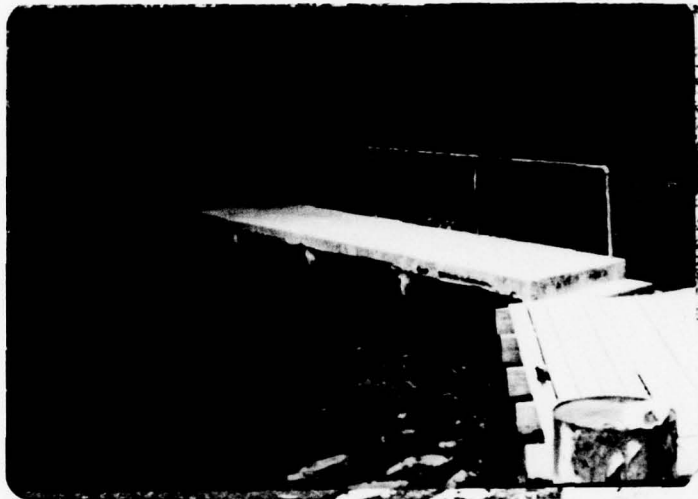
Spillway looking downstream.  
Note: Gravel covering former  
vortex location in foreground.

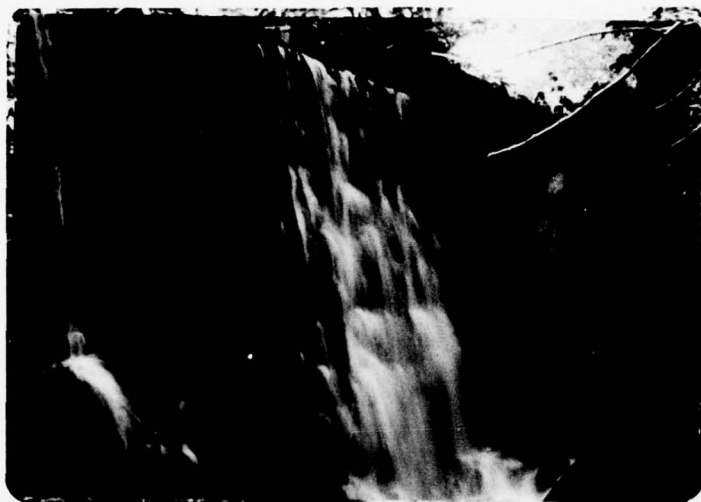
Spillway Looking Upstream

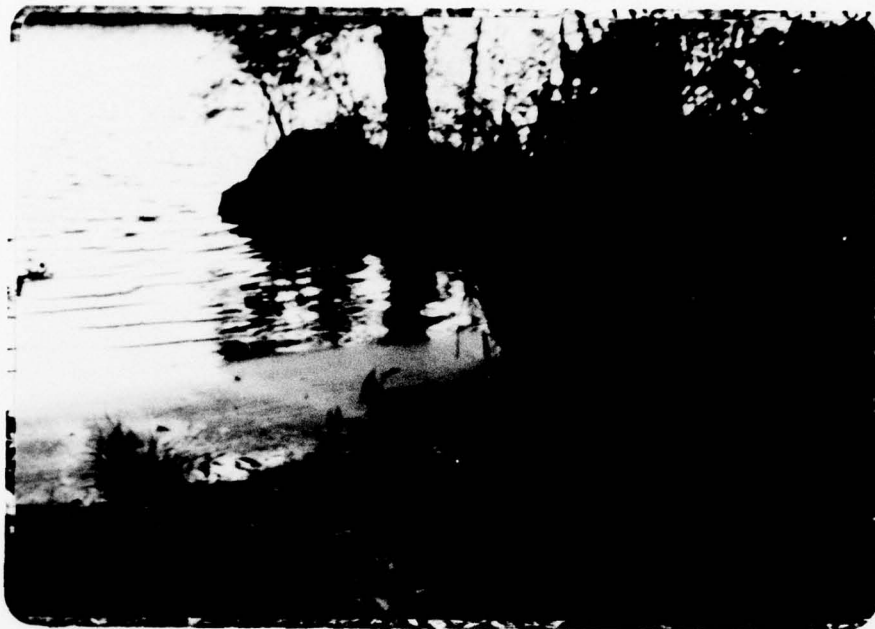
Entrance inlet to Secondary Spillway 12 June 1978

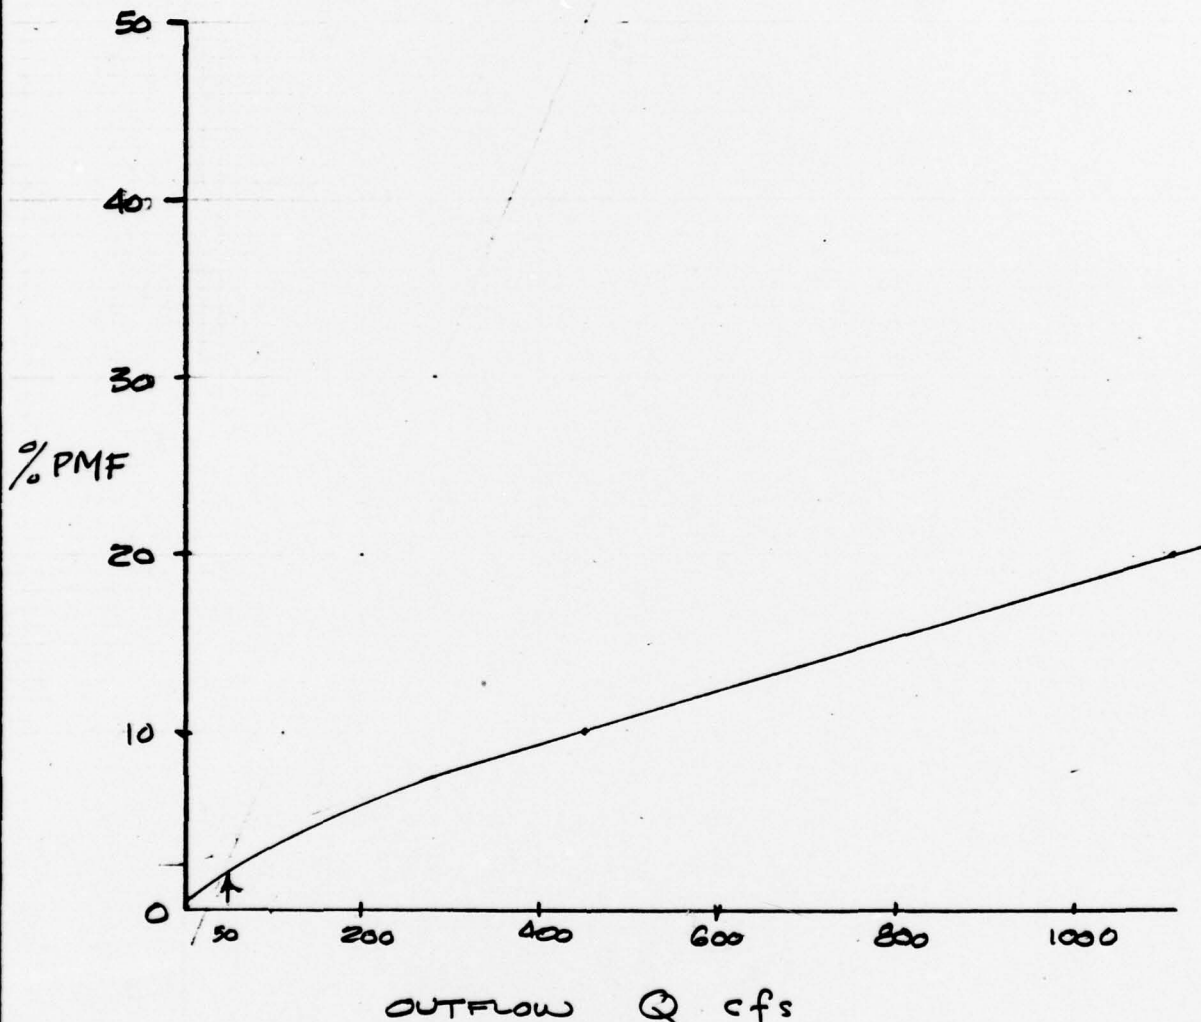
3. OVERTOPPING OCCURS AT EL  $\approx 792.1$  ( $H=0.4$ )  $\rightarrow Q=51$  cfs  
 $\therefore$  DAM CAN PASS 2% PMF W/O OVERTOPPING

6. The spillway capacity as determined by CE screening criteria is seriously inadequate. We estimate the spillway can adequately pass only 2% of the PMF. The actual capacity of the spillway should be determined using more precise and sophisticated methods and procedures. The need for and type of mitigating measures should be determined. Around the clock surveillance during periods of unusually heavy precipitation should be provided, and a warning system established. This should be done soon.
